Structural Analysis of Historical Constructions

Damage observation and settlement mechanisms in the naves of the Cathedral of Milan

G. Cardani, D. Coronelli & G. Angjeliu
Politecnico di Milano, Milan, Italy

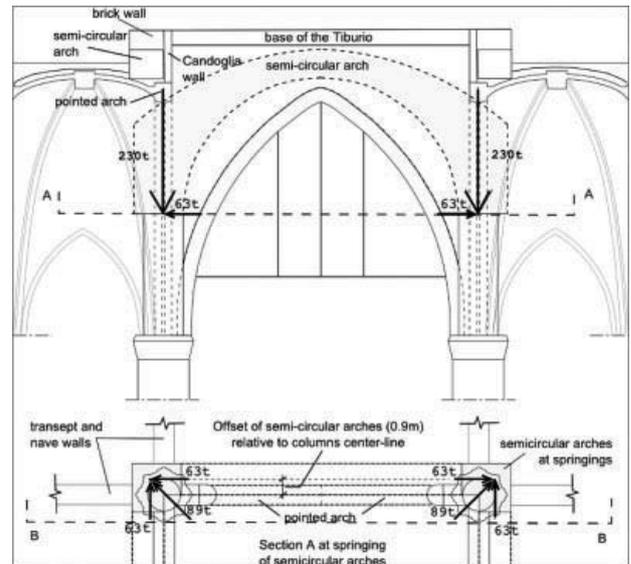
Figure 3. The effect of the Roman arches thrust in the nave and choir prior to Tiburio Construction, South West of the Tiburio.

The four Roman arches thrust laterally onto the surrounding structure, buttressed by the walls above the arcades in the choir, transepts and nave (Fig. 3 for one arch spanning East to West). Two historical periods are considered: (I) 1460 with the decentering of the Roman arches, without the Tiburio loads on top; (II) with the Tiburio and main spire built, until the placing of new ties in this zone around 1970. Considering the constructive phases, the thrust ranges from (a) minimum to (b) maximum. The horizontal and vertical reactions H and V obtained from static calculations (Coronelli et al., 2015) are:

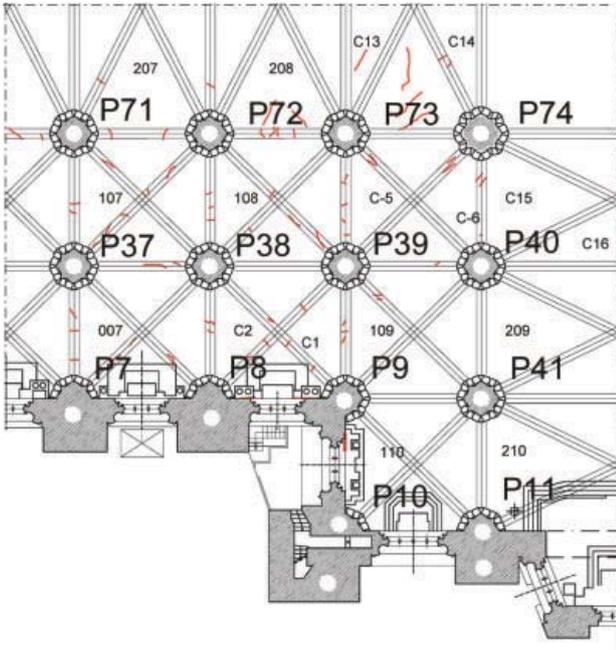
Figure 4a. Crack pattern survey of the South vaults near pillar 74 of the Tiburio.

A visual inspection of the naves of the cathedral has been started. The results, here presented, consist of the crack pattern survey of the vaults near one of the four main Tiburio pillars: P74, South-West oriented. The vaults are named C1/C2, C007, C108 and C107 (Figs. 2 and 4).

The major cracks visible in the above mentioned vaults are located in some arches and ribs but no cracks are visible on the vaults bays (Fig. 4a).

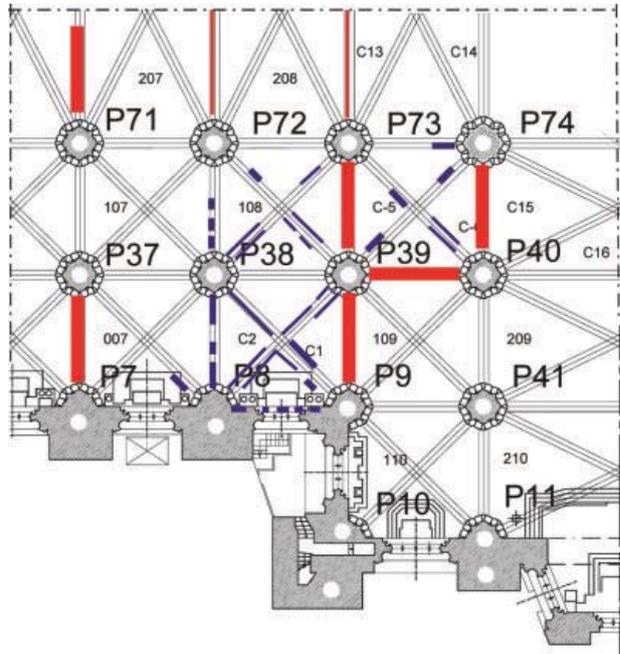
The crack pattern survey is also correlated with a survey of the repaired arches, realized with the substitution of damaged stone units. Figure 4b shows how the concentration of repaired stones is exactly oriented near the Tiburio, along its diagonal thrust. Other important data available from the monitoring of the columns base settlement and their verticality are also taken into consideration.

Figure 4b. Schematic representation of the replaced damaged stone units (in dark colour) of the vaults near pillar 74 of the Tiburio with the indication of higher stressed tie rods (thick red lines).

the area analyzed here, (between pillars 39-9 and 37-7), are the ones presenting the highest tension values in all the cathedral (Fig. 4b).

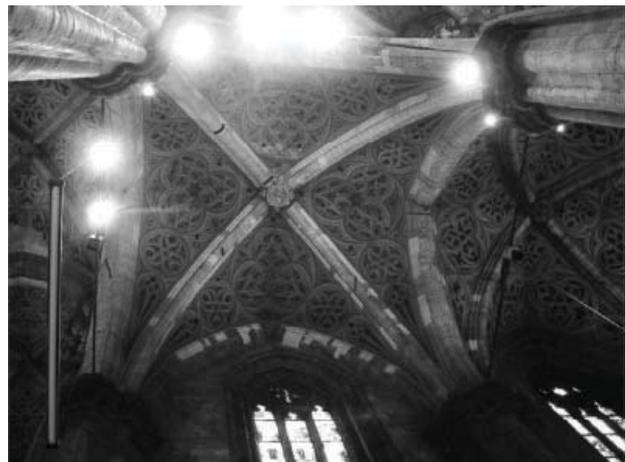
Figure 5. Small visible transversal cracks on the C1/C2 vault ribs and substituted stone units (the lighter colored units). The Tiburio is localised top left.

The vault C1/C2 along the diagonal thrust of the Tiburio presents an extremely high number of replaced stones, consequence of a serious occurred damage, that also justified the strengthening intervention visible on the extrados with r.c. structures, made about twenty years ago, as mentioned in section 2. Nevertheless, the arches and ribs still present few but new very thin transversal cracks mainly localized on the rib along the diagonal of the Tiburio thrust (Fig. 5).

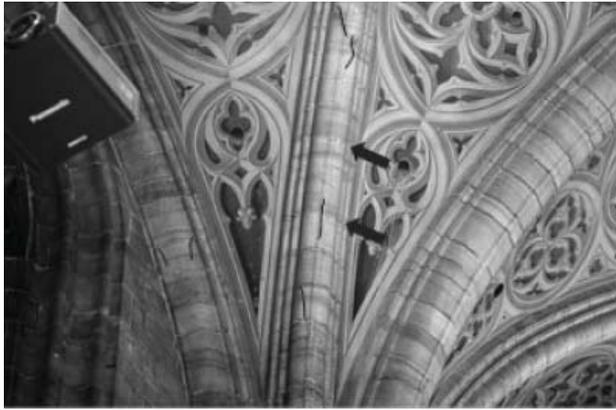
Figure 6. Longitudinal cracks and crushing of the stone units (indicated by the arrow) on the C007 vault ribs.

likely there was not damage on it, during the past repairing works of the near vaults. However this vault is now presenting: a) longitudinal thin cracks along the ribs and b) localized crushing of stone units. The arrows in figure 6 show the localization of the crushing effect at the contact of some ribs stone units. Both phenomena indicate a high level of compression of the ribs mainly visible towards the South.

It does not appear evident that these ribs could have been already damaged twenty years ago and not repaired. It is most likely that a new redistribution of stress has started, due not only to the extensive strengthening intervention of the Tiburio and of the vaults, but also to the continuous leaning of the pillars and soil settlement below the South part of the Tiburio, as monitored by Gicarus Laboratory (Lab. Gicarus 2015) of Politecnico di Milano (Fig. 7).

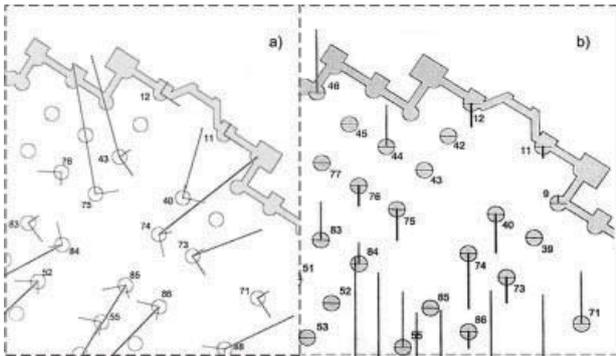
Figure 7. Ongoing monitoring in the Cathedral around Tiburio area: a) pillars out of plumb (1981–2013), with pillar 73 in evidence (segment length represents 2 mm), and b) soil settlements (1966–2014) in the same area (segment length represents 0.8 mm) (Lab. Gicarus 2015).

This analytical scheme is confirmed by the surveys. The westward out of plumb of these columns in 1965 was 6 cm for P74 and 5 cm for P73. The monitoring of lateral displacements (Fig. 7a) between 1981 and 2015 shows a westward component for the top of P74 and P73. The lateral loading of the arches to the side of the Tiburio is confirmed by damage at the crown, observed for instance at the side of P75 (Fig. 15).

The four tiburio piers (eg. P74) and the surrounding columns (eg. P73 and P40) are increasing their out-of-plumb outwards (Fig. 7), approximately along the diagonals. The cause of the out-of-plumb is undoubtedly the thrust of the tiburio analysed above.

In figure 7 column P74 shows the highest settlement, and the differential settlements of the foundations and out-of-plumb in the area at study are high. Relative movements of P73 with respect to P39 were the cause of the tie failure in figure 8. The surveys and repair operations show that most past and present damage is in the vaults between P74 and P7-P8-P9.

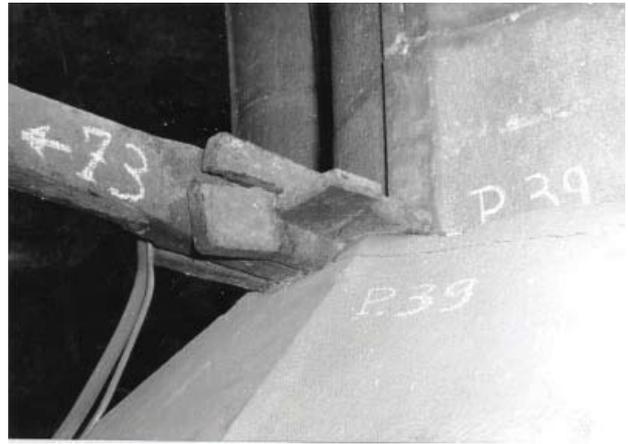
Figure 8. Survey in 1960 showing the failure of the tie rod anchorage on the South aisle between pillars 73 and 39.

Considering in particular the Tiburio pillar 74, as well as the nearby pillar 73, both showed a high rotation outwards in the South-West direction also before the extensive strengthening interventions in the '80s. Ferrari da Passano observed in the '60s the break of the tie rod between pillar 73 and 39 in South direction

(Fig. 8). Today those pillars are still moving slightly toward South, as confirmed by the still high tension of the new tie rod between pillars 73 and 39, as well as of the tie rods around Tiburio pillar 74.

This balance was possible though with lateral drift producing damage to the stone masonry on the west side of the columns, shown by several surveys in the 20th century. The drift of the columns of the arcade aligned with the thrust H is confirmed also by some failures of the ties connecting these members to the outer line of columns between the aisles; an example is shown in Figure 8.

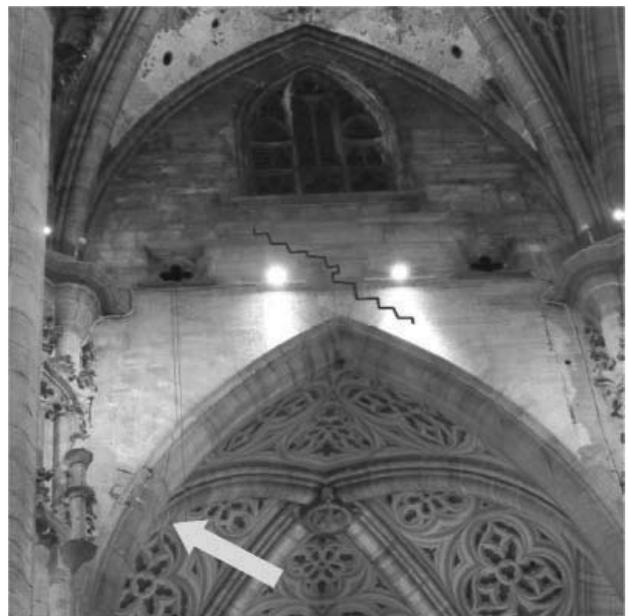
Figure 9. Damaged arch between the two South aisles near Tiburio (P37-P38) and diagonal crack on the upper wall.

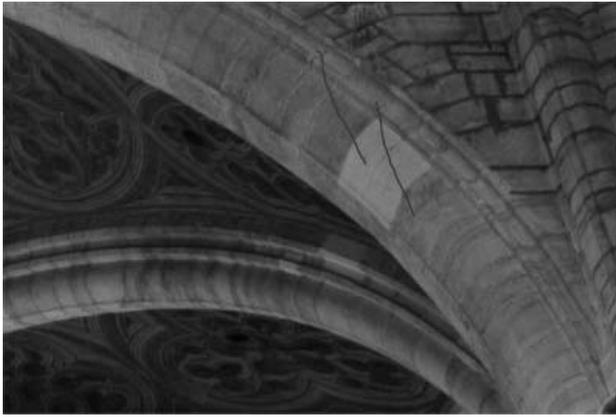
Figure 10. Cracks of a replaced stone unit in an arch of the aisles near Tiburio.

The area at study is characterized by significant differential settlements. One of those effect is the diagonal crack visible on the longitudinal wall between the two South aisles (the C007 vault and the adjacent C107 vault) and the damage of the below arch, visible in figure 10.

The combination of these small but constant and differential movements could be the main causes of the new observed damage that should be constantly monitored, starting at least with the visual but periodical inspection. As an example, a new crack has formed again where stones units were replaced (Fig. 10); this is one of the first signals to be observed of the current movements. Similar cracks are visible on the new stone units of vault C5/C6 repaired in 1993.

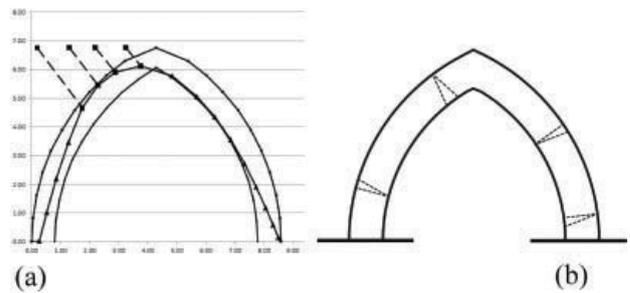
Inclined cracking is observed in the wall between P74 and P73 (Fig. 13b) related to diagonal force transfer; the same damage is found in all eight walls at the four corners of the Tiburio. It is assumed that the shear resistance of the wall is reached; considering the vertical load given by its weight, using a Mohr-Coulomb

Figure 13. Calculated thrust lines and theoretical mechanism for lateral loading in the longitudinal arches (50% of thrust H).

The thrust D (Fig. 12) loads laterally the pointed arches near the Tiburio. Using the static approach the thrust line in these arches is obtained (Fig. 13a) under the gravity load and the shear force in the cracked wall, previously calculated. Figure 13b following a kinematic approach shows a possible mechanism related to the lateral loading.

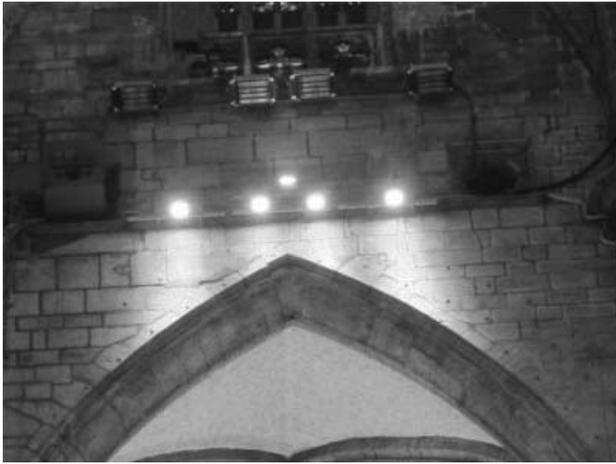
Figure 14. Damage with stone sliding at the crown of an arch.
