# Metallurgical characterisation of a historical metal tie-rod from Milan Cathedral

One tie-rod from Milan Cathedral (15th century) recently broke in a defective cross-section. In order to infer the causes of failure, a metallurgical characterisation was performed, the results of which are discussed here. First, a visual inspection of the specimen was performed. Next, the fracture surface was analysed using a Scanning Electron Microscope (SEM) combined with Energy Dispersive X-Ray Spectrometry (EDXS) to detect the failure modes involved. A cross-section close to the failure surface was investigated by means of Stereoscopy, Light Optical Microscopy (LOM), SEM and EDXS in order to identify the microstructural compounds and characterise the slag inclusions. Vickers and Rockwell hardness tests were also carried out to correlate microstructural observations with mechanical properties. A strong relationship between failure and defects due to forging was observed, which is a particularly noteworthy result with regard to the representativeness of laboratory tests and the viability of in-situ inspection.

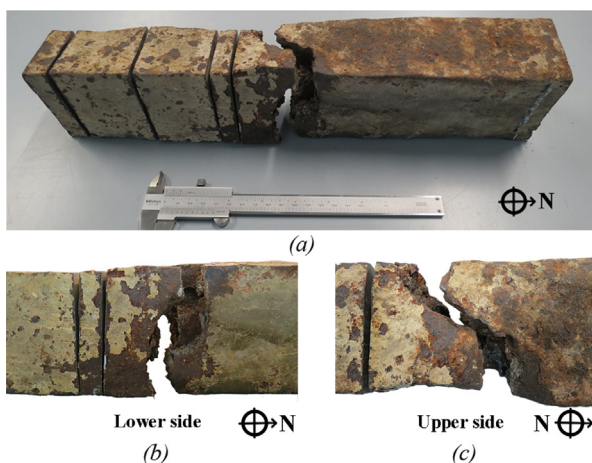
Fig. 2. Investigated portion of tie-rod 59-88, a) general overview, b) enlargement on the broken profiles, lower side, c) enlargement on the broken profiles, upper side.

The cross-section has different dimensions on the two sides of the failure plane: this suggests that several bars may have been assembled to obtain the entire element. The failure profile is inclined with respect to the tie-rod length.

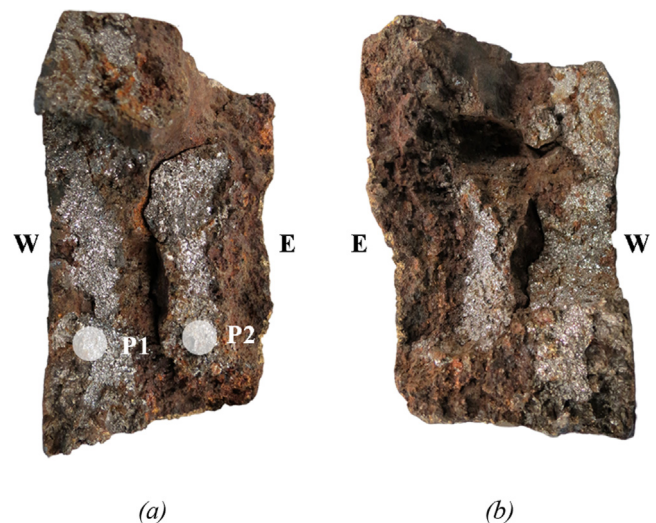
In Fig. 3, the two fracture surfaces (indicated as sample A1 and sample A2) are shown. They exhibit the typical fibrous appearance of wrought iron, oriented according to the tie-rod length. A visible crack can be observed intersecting both failure surfaces. It takes the form of a large void in the inner part of the cross-section while the tips point outwards. A more deformed zone can be identified on the lower part. A no-planar fracture can be recognised. The surface appears either shiny or oxidised depending on its position on the cross-section. The failure surfaces are extensively oxidised. Dark oxides and red oxides can be distinguished visually.

Fig. 3. Failure surfaces and localization of SEM analyses, (a) sample A1 oriented southward, (b) sample A2 located northward.

The two failure surfaces provide interesting information about the failure mechanism. Dark oxides are usually produced at the forging temperature and hence are a result of the manufacturing process; red oxides, commonly known as “rust”, form at room temperature. The latter are fairly evenly distributed over the whole cross-section and are caused by atmospheric corrosion. This evidence is in agreement with the results of microclimate monitoring [17], which revealed that for most of the year relative humidity exceeds the recommended limit of 50%, favouring the onset of corrosion in metallic materials. However, the characteristics of the fracture surfaces, as well as the generalised corrosion itself, indicate a failure that was mainly determined by mechanical properties, defectiveness and load conditions. It is reasonable to assume that the crack nucleated inside the section in a weaker region of the material of sizable dimensions (~5–8 mm), where local stress concentration occurred. The position of the visible crack across the specimen slices suggests an inclined propagation relative to the tie-rod length. Non-homogeneous mechanical properties can

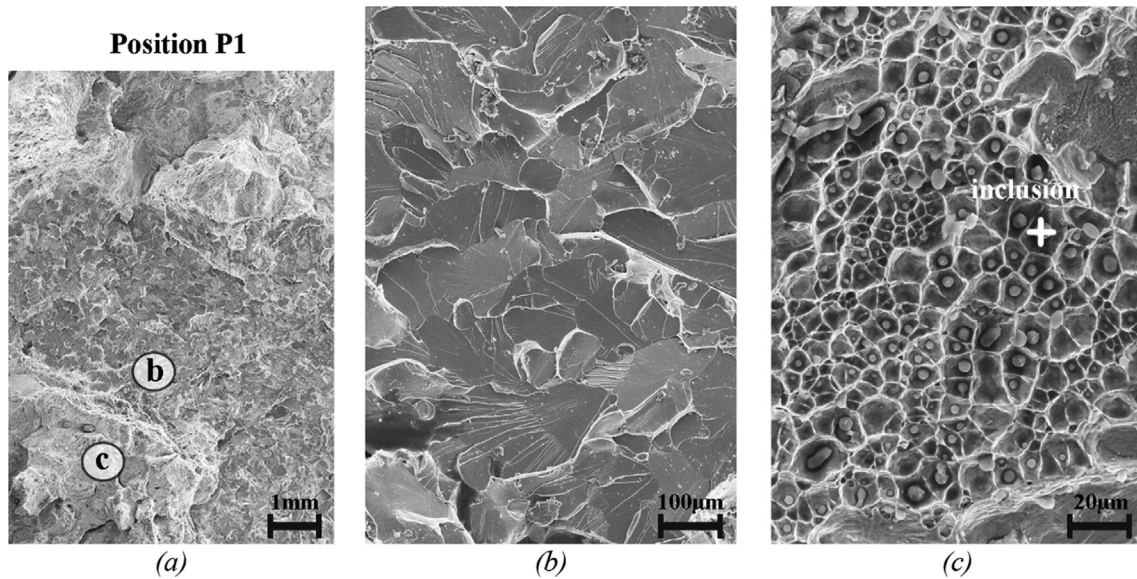
Fig. 4. SEM analyses on sample A1 at position P1. (a) general picture, enlargement on (b) transgranular brittle failure area, (c) ductile failure area.

These tear ridges tend to merge in the direction of crack growth: a downward direction of propagation is suggested. In contrast, Fig. 4c and Fig. 5c clearly show dimples, which indicate a microvoid coalescence around discontinuities such as non-metallic inclusions and impurities. Dimples are symptomatic of a ductile fracture mode. Compositional analysis was performed by EDXS on the inclusion inside a dimple shown in Fig. 4c. As can be seen in Table 1, the main element detected (excluding Fe, C, and O) is Si.

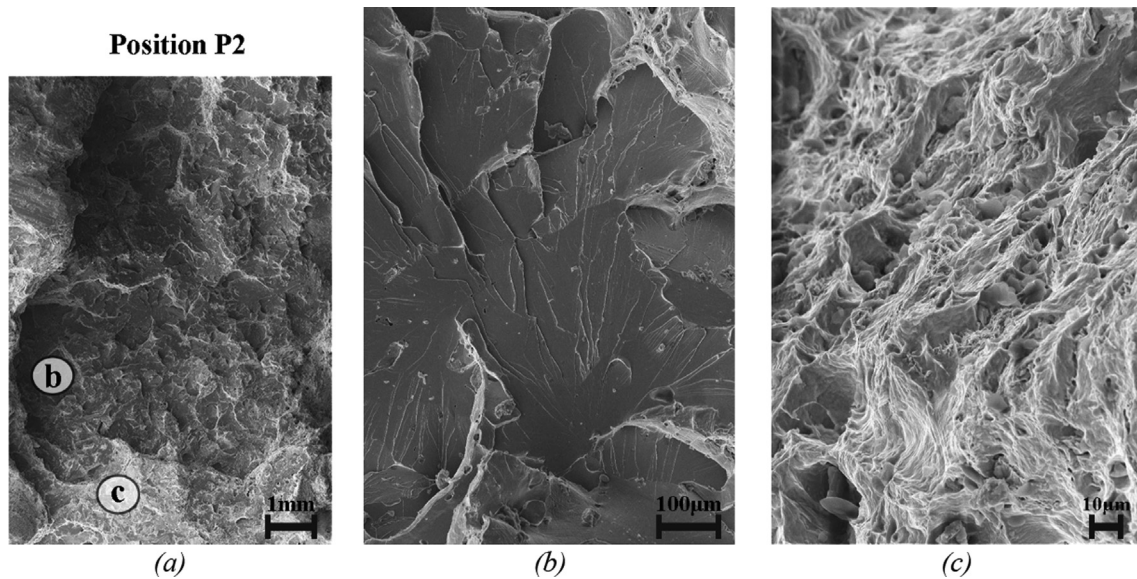
Fig. 5. SEM analyses on sample A1 at position P2. (a) general picture, enlargement on (b) transgranular brittle failure area, (c) ductile failure area.

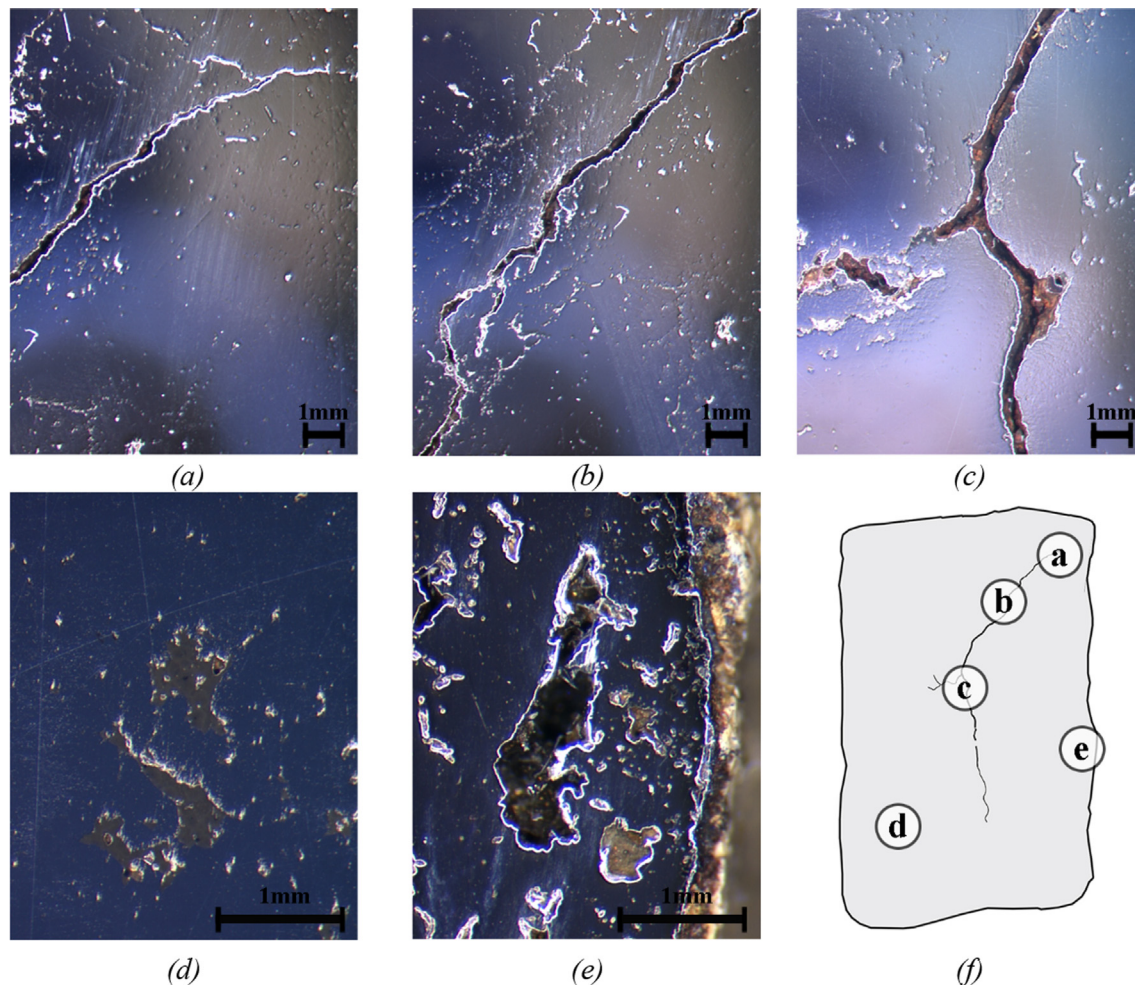
A visible crack crosses the whole specimen. Inside the crack, rust was detected (Fig. 6b and c), suggesting that the crack is not of recent formation. The material is highly defective and many kinds of discontinuities were distinguished, such as porosities, inclusions, macrovoids, and microcracks. Discontinuities of micrometric dimensions or smaller are more concentrated mainly close to the visible crack (Fig. 6a and b). Larger flaws are randomly distributed, especially on the westward portion of the cross-section

**Fig. 6.** Stereomicrographs on sample B (a) crack tip, (b) concentrated discontinuities close to the main crack, (c) crack bifurcation, (d) isolated discontinuities, (e) hammerslag layer and voids (f) localization of pictures.

(Fig. 6d). A 0.2–0.3 mm-thick hammerslag layer (oxide produced during hot working) covers the tie-rod (Fig. 6e). It is almost uniform and coherent with the wrought iron core and has probably had a protective effect against corrosion. Very large voids are located below the crust at a depth of up to 15 mm.

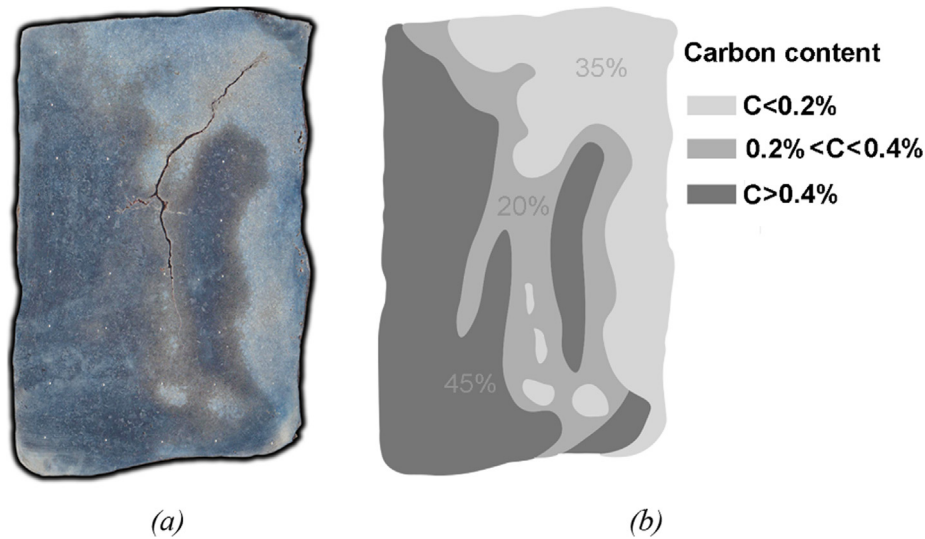
As other studies, including [6], have suggested, some preliminary qualitative insights can be obtained by observing the etched section, the superficial features of which depends on the carbon content. Usually the areas with a carbon content of over 0.2–0.3% appear more opaque. This indication allows an initial distinction to be made at the macro scale between regions characterised by different carburisation states. As Fig. 7b shows, three different conditions can be distinguished:

- 35% of the surface has a C content lower than or equal to 0.2%;
- 20% of the surface has a C content ranging from 0.4% to 0.2%;
- 45% of the surface has a C content greater than or equal to 0.4%.

Fig. 7. Carbon content evaluation at the macroscopic level (a) real surface after etching, (b) categorization of the cross-section area.

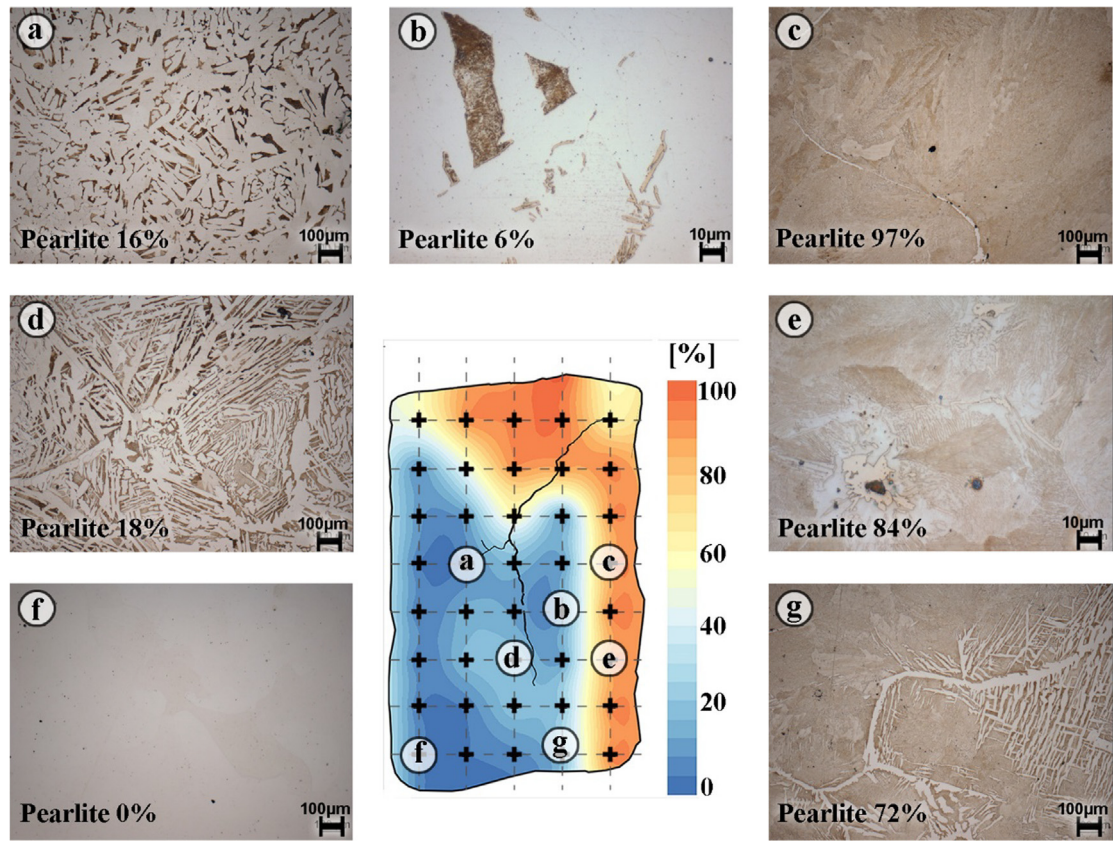
Micrographs at 100X were taken at each node. Fig. 9a–g show several of the microstructures identified. The fractions of the microstructural compounds were determined according to ASTM E 562-02 Standard Test Method for Determining Volume Fraction by Systematic Manual Point Count [34]. A highly heterogeneous distribution of the two main microstructural compounds was observed: the percentage of pearlite ranges from 97% (Fig. 9c) to 0% (Fig. 9f). The grid nodes were classified into three categories depending on the percentage of pearlite (Table 2). The discrete data system was transformed into a continuous distribution by interpolating the nodal values and the results were plotted in the coloured contour map shown in Fig. 9. An examination of the LOM micrographs reveals that ferrite nucleates at the grain boundary and grows with lamellar shape. Especially in Fig. 9d, Widmanstätten plates can be observed. In addition to ferrite and pearlite, cementite was occasionally detected (Fig. 9b and e).

**Fig. 9.** Detected metal matrix via LOM (a) pearlite 16%, (b) pearlite 6%, (c) pearlite 97%, (d) pearlite 18%, (e) pearlite 84%, (f) pearlite 0%, (g) pearlite 72%,(h) pearlite distribution and micrographs locations.

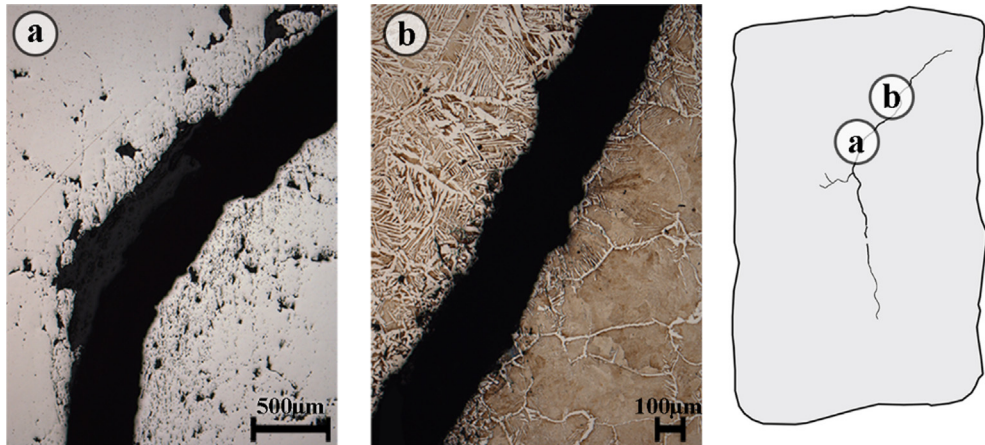
The area close to the macroscopic crack was also analysed in detail. Fig. 10a and b are illustrative pictures taken by optical microscope before and after etching, respectively. Concentrated inclusions and a sudden change of both microstructure and grain size can be observed across the crack.

**Fig. 10.** Microstructure close to the visible crack (a) concentrated discontinuities, (b) sudden microstructure changes (c) micrographs localization.

The tie-rod failure analyses of the replaced element confirm this insight. The crack propagated along an inclined direction with respect to the longitudinal tie-rod axis, recalling the typical forged weld shape. Moreover, the crack visible over the cross-section is located across a region where concentrated discontinuities and sudden change of microstructure occurred, as shown via LOM before and after etching. As mentioned previously, in the literature

these two occurrences are often associated with the presence of forged welding of two wrought-iron pieces [6]. This evidence, combined with the results of visual inspection, leads to the hypothesis of crack propagation along a forged weld, which is in agreement with the lower toughness observed at these locations.

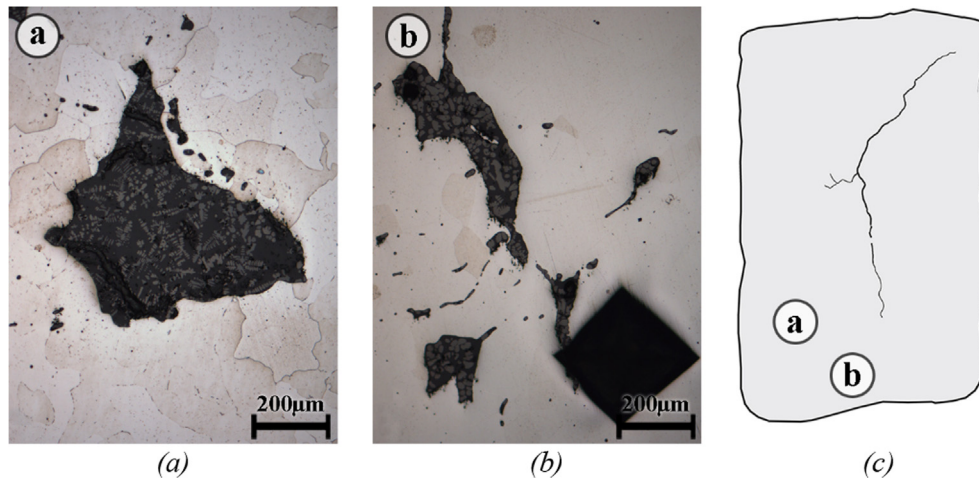
**Fig. 11.** LOM analyses on the two-phase inclusions detected in ferrite matrix. (a) wüstite and glass, (b) fayalite and glass, (c) micrographs localization.

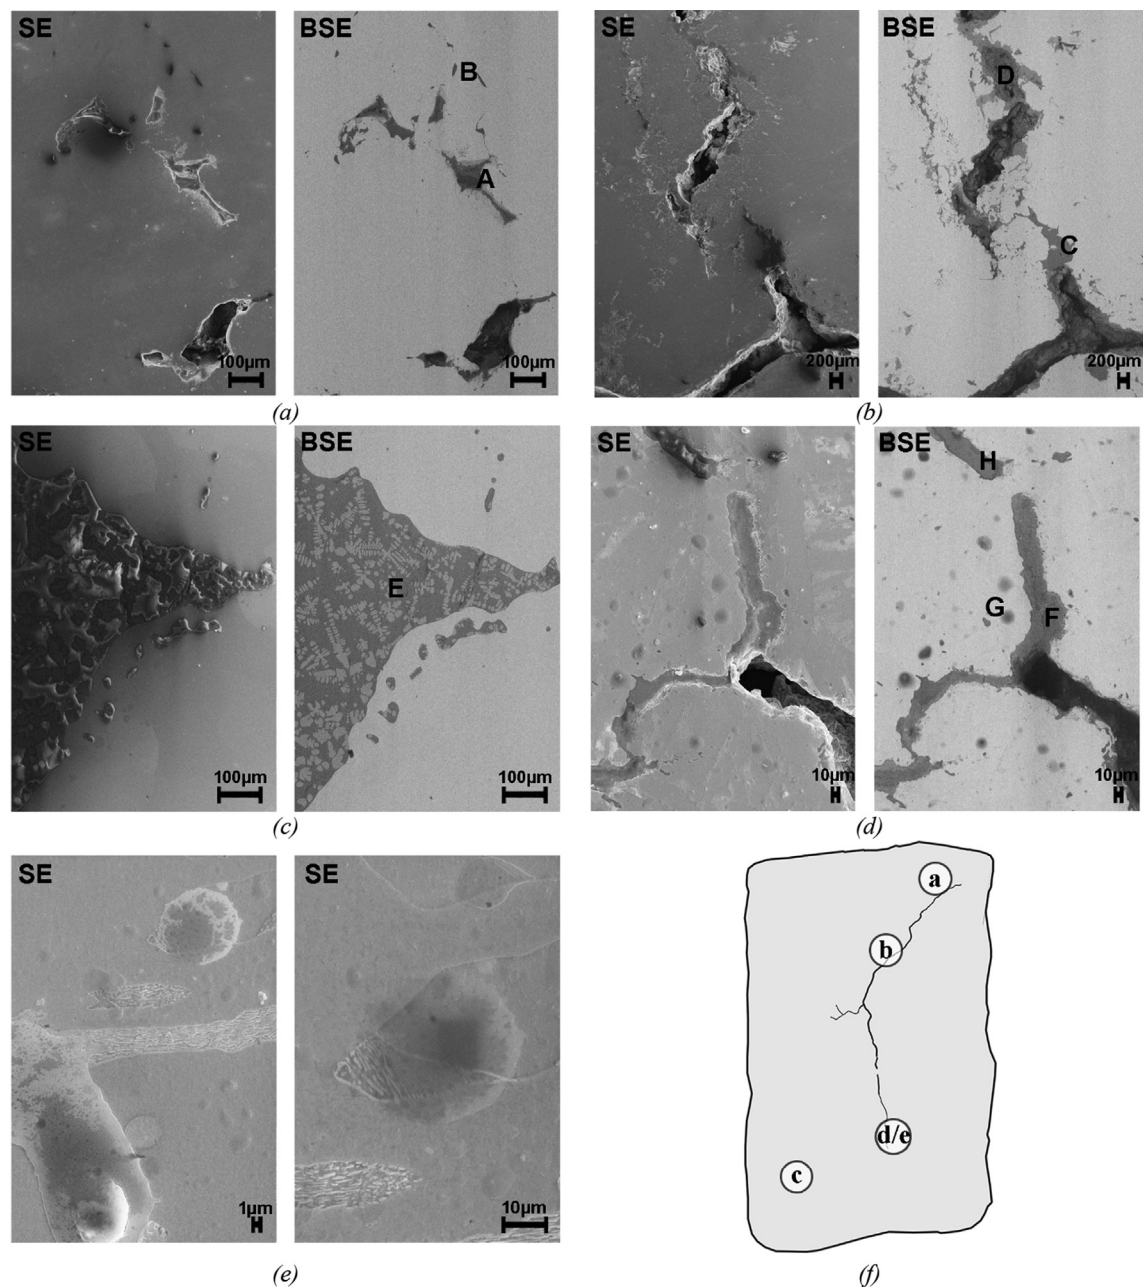
- close to the upper tip of the visible crack (pearlite 60% and ferrite 40%, Fig. 12a);
- close to the widest part of the visible crack (pearlite 62% and ferrite 38%, Fig. 12b);
- undamaged material (pearlite 0% and ferrite 100%, Fig. 12c).

- close to the lower tip of the visible crack (pearlite 20% and ferrite 80%, Fig. 12d).

The pictures in Fig. 12a and b were taken of material characterised by approximately the same percentage of ferrite and pearlite. Different types of inclusions were revealed. In Fig. 12a, the particularly high percentage of Si (about 63%) at the A-inclusion suggests a glassy SI (iron content is negligible). In contrast, the chemical analysis of the B-inclusion in Fig. 12a and the C-inclusion in Fig. 12b suggests an iron-rich glassy composition. As expected, inclusions of rust were identified inside the crack (D-inclusion in Fig. 12a), as indicated by the detection of mostly Fe and O.

In Fig. 12c, the metal matrix is pure ferrite (0% pearlite). The detected inclusion has a bulky shape and a pale dendritic phase with a glassy appearance. EDXS analysis reveals a Fe-rich inclusion with a significant amount of Si (13.10%). More specifically, it is characterised by dendrites of wüstite (FeO) in a glassy matrix. There is also a significant presence of Ca and Mn, the content of which is 4.75% and 6.33%, respectively. Carbon is completely absent. The morphology is very similar to inclusions in Fig. 11, as detected by LOM. Indeed, the same metal matrix surrounds it.

The picture in Fig. 12d shows the mostly ferritic microstructure (80% ferrite and 20% pearlite). EDXS on the F-inclusion revealed iron oxides, as in the other inclusion analysed inside the crack. The G-inclusion is spheroidal graphitic carbon, the enlargement of which is shown in Fig. 12e. Its size is about 10–15  $\mu\text{m}$ . This kind of inclusion is recurring in the mostly ferritic iron part of the sample. Around nodules, a finer pearlite can be usually found, becoming progressively coarser. H-inclusion in Fig. 13d is iron-free, with high percentage of Si, Ca, and Mn.

**Fig. 12.** SEM analysis, SE mode and BSE mode with EDXS localization on different metal matrix. (a) pearlite 60% and ferrite 40%, (b) pearlite 62% and ferrite 38%, (c) pearlite 0% and ferrite 100%, (d) pearlite 20% and ferrite 80%, (e) enlargements on carbon nodules, (f) micrographs location.

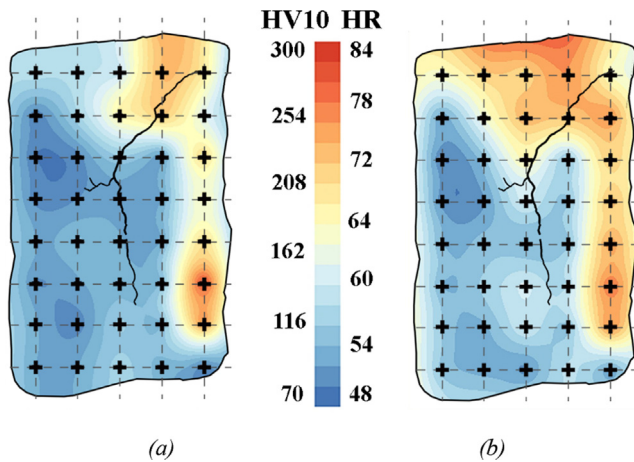
the different material properties over the cross-section, which may be more brittle or more ductile depending on microstructure. The discrete Vickers and Rockwell hardness data were converted into coloured contour maps, which are reported in Fig. 13a and b respectively.

The Vickers hardness values fall within the 79–284HV10 range and have a mean value of 132HV10 (standard deviation 55HV10). The Rockwell hardness values range from a maximum of 79HR to a minimum of 50HR and have a mean value of 61HR (standard deviation 9.2HR). The large difference between the minimum and maximum values suggests that the penetrator alternately delved into softer and harder phases. Therefore, characteristic Vickers hardness values of pearlitic, ferritic, and ferritic-pearlitic structures were estimated by classifying the grid nodes as follows:

Fig. 13. Hardness values distribution, a) Vickers HV10, b) Rockwell HR.

The microstructural findings in terms of matrix and types of inclusions show a strong agreement with the hardness testing results. The distribution of Vickers and Rockwell hardness values can be completely overlapped with the pearlite content map: higher hardness values correspond to the mostly pearlitic microstructure with mainly silica-rich inclusion while the lowest ones correspond to the mostly ferritic microstructure with iron-rich inclusions. With regard to hardness values, the comparison with similar case studies is not meaningful because small differences in the metal matrix as well as in grain dimensions may strongly influence the results.
