The analysis of the main spire reversed arches of the Cathedral of Milan

D. Coronelli, G. Cardani & G. Angeliu

Politecnico di Milano, Milan, Italy

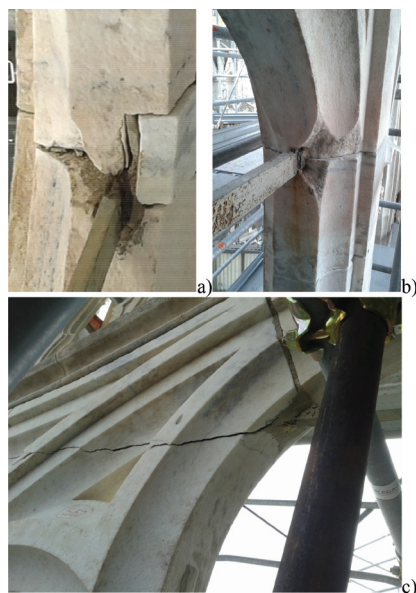
The main spire reversed arches show clearly the maintenance carried out along the years, with new stone elements placed to substitute the damaged ones and new mortars with different composition to repair the bedding joints and units detachments. The main cracks and detached parts are located on the stone units near the insertion of the tie rods, where the external and internal iron elements are seriously corroded (Fig. 3a,b).

Iron tie rods were seriously damaged since the end of the XVIII century due to weathering (rain water, thermal deformation, wind and pollution). Also different dynamics actions, like some seismic tremors, lightning may have affected over the years the efficiency of the tie rods. Weathering strongly

Figure 3. Corroded iron connecting ties: a) reduced section of the tie in AT3, b) detached stone elements in At1 and c) horizontal stone crack along the tie in AT6.

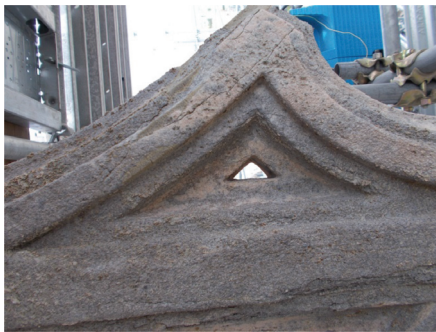
affected the surface of the Candoglia marble units (Fig 4) and bedding mortar with deep erosion but other cracks typologies of structural nature are visible and in continuous evolution (Fig.5a,b).

Figure 4. Candoglia marble stone unit damaged by weathering in AT6.

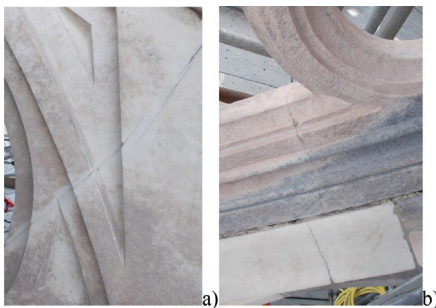
Figure 5a,b. Structural cracks on marble units: a) cracks on an old stone unit in AT6 and b) crack going through an old and a replaced marble unit in AT4.

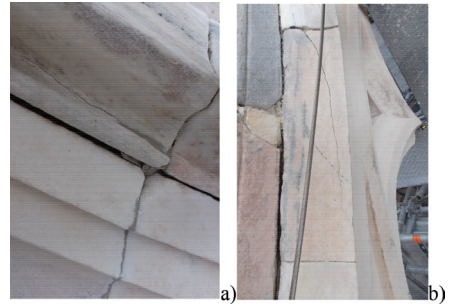
- a. the arches on the South side of the spire AT1 – 4 present longitudinal cracks on the long stone units forming the curved part (Fig. 6) as mainly visible in the arch named AT4. The cause of these cracks can be attributed to high compression stresses along the arches, combined sometime with the oxidation of the interior iron staples. In the North side arches, this crack typology is absent.

Figure 6. a, b. Longitudinal cracks due to compression stress: a) in AT3 and b) in AT4 arches.

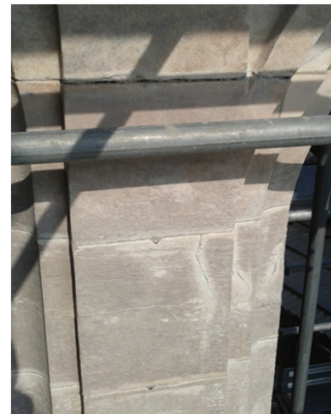
- b. the vertical narrow pillars below the reversed arches, placed at mid span between the main spire and the external buttresses, present vertical cracks compatible with the high compression stress induced by the thrust line in the arches. (see the crack pattern survey in the section AT5–1 arches and section AT6–2 both North—South in figures 9 and 10). Arch AT6 in the North side, which is one of the most damaged ones, presents in addition horizontal cracks due to flexural stresses. This phenomenon demonstrates clearly that all these reversed arches,

Figure 7. Vertical cracks on small pillars in AT8.

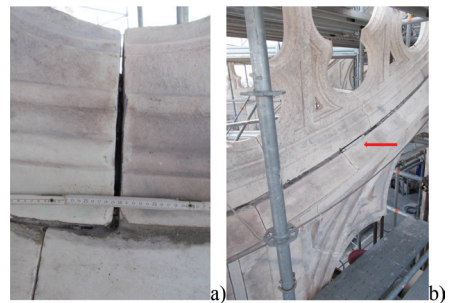
Figure 8. a, b. Detachment between stone units: a) at the extrados of the arches (AT7) and b) along the longitudinal units (AT6) where a wooden ruler is inserted in the bedding mortar.

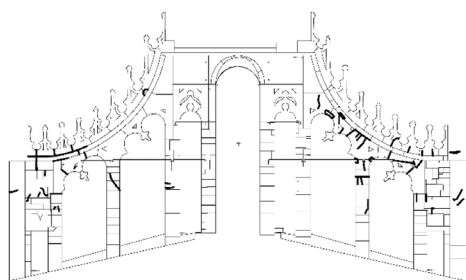
Figure 9. Survey of the arches AT5 (left) and AT1 (right).

In Figs 9–10 the crack pattern survey is reported on some reversed arches to highlight the different condition in the opposite arches. Cracks are here emphasized in dimension to be readable at the reported scale.

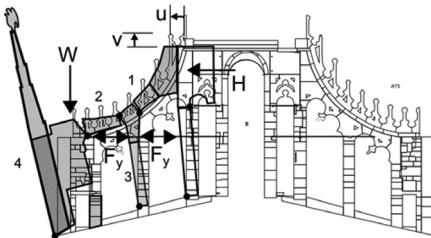
Figure 17. Theoretical mechanism 1 $\lambda = 2.96$ all arches are active (configuration 1); 1 $\lambda = 1.93$ one arch is deactivated (configuration 2).

The first mechanism could take place with the yielding of the tie (Fig. 17). The cracks (hinges) that connect the blocks are formed in the parts with limited section. The load computed from this mechanism is nearly three times higher ($\lambda = 2.96$, 1st configuration) and two times higher ($\lambda = 1.93$, 2nd

configuration) than the computed wind load, determining thus an upper bound of the level of safety.

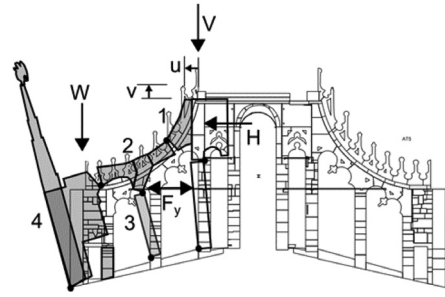
Figure 18. Theoretical mechanism 2; $\lambda = 1.65$ all arches are active (configuration 1); 1 $\lambda = 0.79$ one arch is deactivated (configuration 2).

In the second collapse mechanism (Fig. 18) the load multipliers computed from this mechanism are $\lambda = 1.65$ (1st configuration) and $\lambda = 0.75$, (2nd configuration). Especially the second collapse mechanism lower than the unity shows the absence of the safety in the ULS (ultimate limit state). This result confirms once more the need for strengthening before proceeding with structural repairs.
