Assessment of an industrial pavement *via* the impact acoustics method

Roberto Felicetti

EJECE - 14/2010. On site assessment of concrete structures, pages 427 to 439

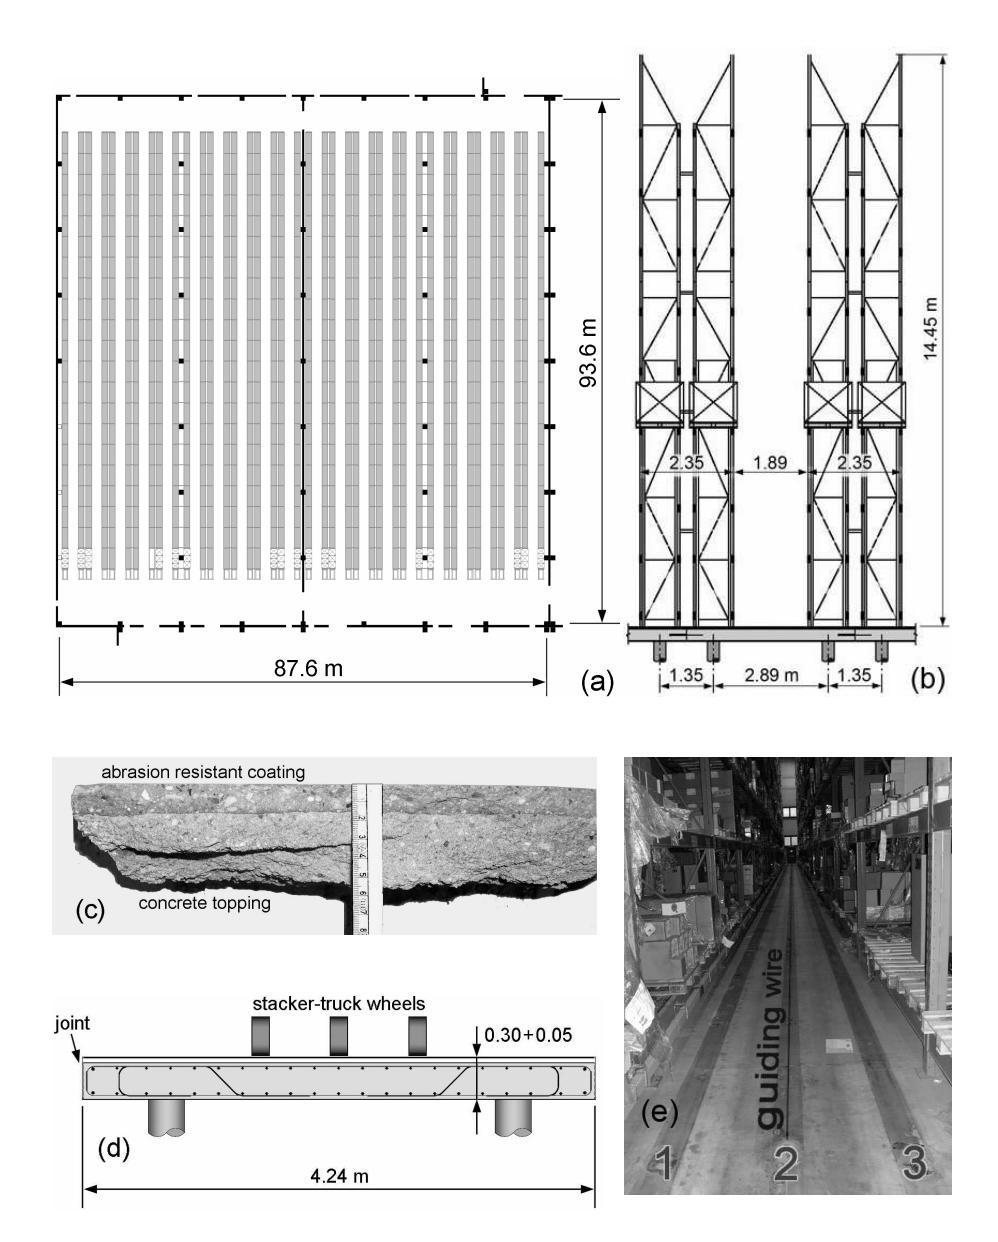
Figure 2. *a)* plan of the investigated warehouse facility; b) cross section of an aisle between the racks; (c) concrete layers forming the 50 mm thick pavement; d) ground-slab strip supported by piles and e) view of an aisle and its flooring

The pavement is based on a 0.30 m thick R/C ground-slab resting on foundation piles, and it is made of a 35-40 mm topping layer finished with a 15 mm abrasion-resistant quartz-concrete coating (Figures 2c, 2d). Detachments of this latter coating have been observed in a number of points along the wheel tracks, as a consequence of the repeated loading-unloading process due to the transit of the stacker-trucks. The reason for this kind of damage may be ascribed to both the not uniform quality of the topping concrete and the bending deformability of the ground-slab, made apparent by a diffuse pattern of transverse cracks on the pavement.

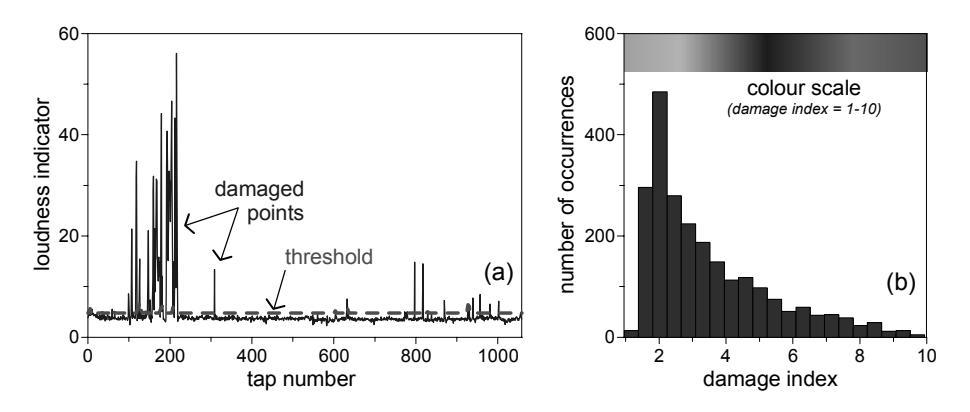
E) Classification of the damage levels and plotting of the damage map. In the 20 access aisles a total of about 2 400 measurements out of 85.000 led to a louder response than the local threshold, indicating a possible incipient detachment of the pavement coating. The incidence of these damage values is shown in Figure 5b, together with the colour scale adopted to summarize the results into damage plots.

Figure 5. *a)* Loudness indicator along one 80 m line (1 066 taps) compared to the adaptive threshold for distinguishing the damaged points and b) number of occurrences of the different damage levels and associated colour scale for drawing up the damage map

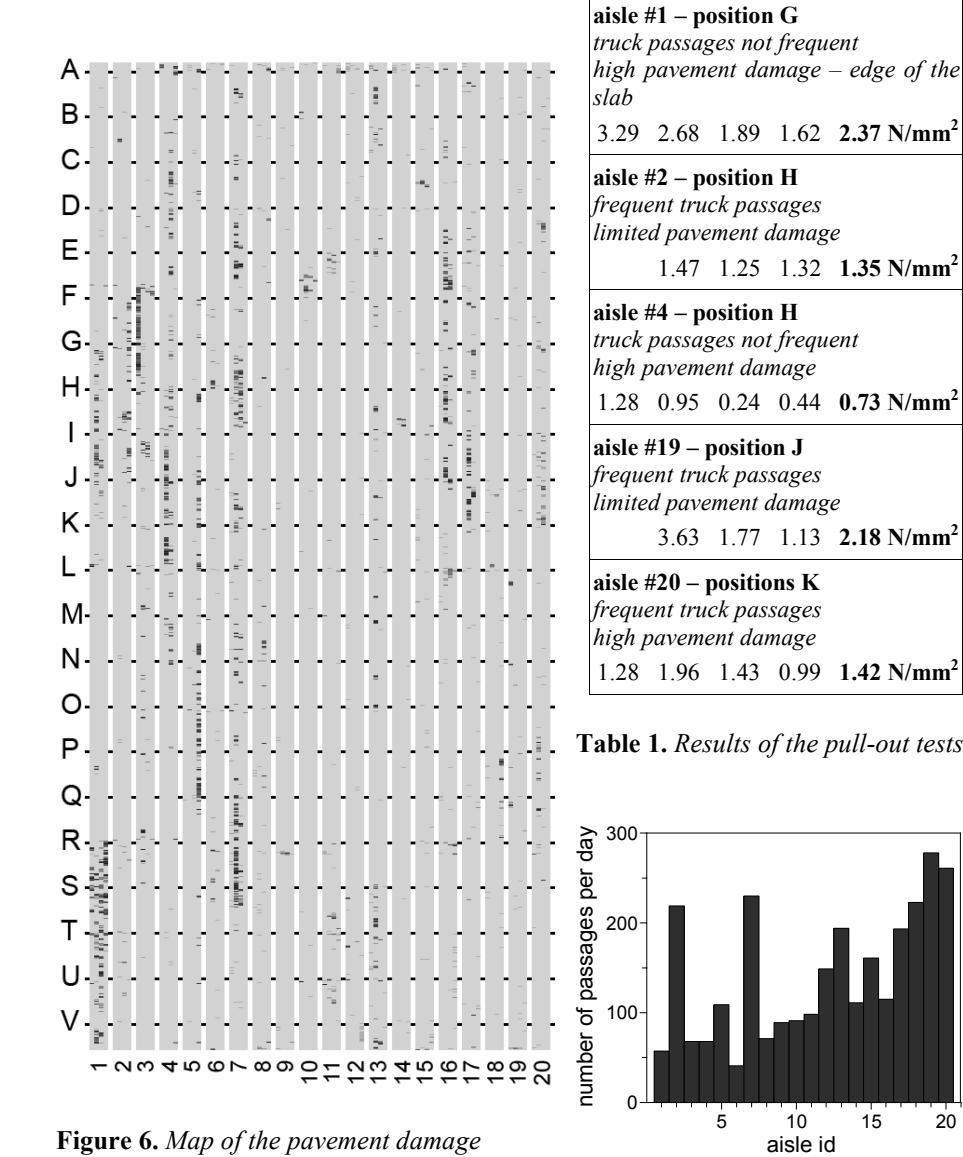
Figure 6. Map of the pavement damage in the inspected logistic facility

After having examined the damage map of Figure 6, the critical parts of the inspected area are quite evident, in the form of coloured stretches extending for 2-4 rack modules along the aisles. The different hues express the whole damage range from incipient (cyan) to completely developed (blue to red) delamination of the pavement coating. It transpires that there are several portions of the pavement which are likely to experience the detachment of the abrasion-resistant concrete coating, especially in the first seven aisles and in aisles 16 and 17.

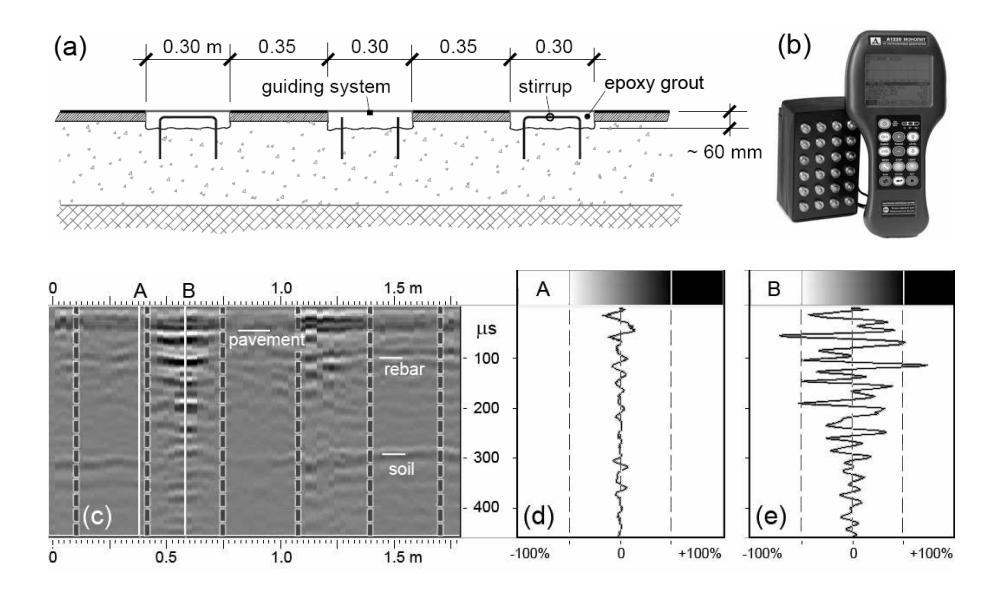
Despite the excellent quality of the grout (compressive strength = 110 N/mm^2 , splitting strength = 11.4 N/mm^2), some pull-out tests on a trial repair patch highlighted the unsatisfactory bond to the concrete substratum (~ 1 N/mm^2). For this reason, one month after opening to service the first repaired aisle, a new check has been performed via the described impact acoustics technique. The outcome is that in

no point the response to the hammer taps could be ascribed to a faulty zone. The check was extended also to the remaining intermediate strips of the old flooring, obtaining somewhat worse results (maximum damage index slightly higher than 1). Though less influenced by the moving loads, these latter parts were in fact just marginally stabilized by the side repair patches.

Figure 8. *a)* cross-section of the repaired pavement; b) ultrasonic device for the implementation of the shear pulse-echo technique; c) B-scan across a repaired cross-section and d)-e) A-scans pertaining to a repaired point and to a remaining piece of the old pavement

In order to deepen this aspect, the shear waves pulse-echo technique has been implemented along a transversal cross section of the aisle. A dedicated instrument has been used (Acoustic Control Systems A1220 - Figure 8b), in which the transmitting and receiving sensors are integrated in a single array of 12 + 12 dry-contact point transducers. The results, either in the form of time-amplitude plots (A-scans, Figures 8d, 8e) or time-position-intensity cross-sections (B-scan, Figures 8c), confirm the definitely good response of the repaired parts of the pavement, with just very low reflections corresponding to the depth of the steel reinforcement and of the soil interface (after 100 and 300 µs - Figures 8c, 8d). Across the old lining the far stronger signal supports the indications of the hammer-tapping technique (Figures 8c, 8e). In actual fact this response can be hardly ascribed to the multiple reflections of the ultrasonic pulse, being the delamination too shallow compared to the recognized limit of applicability of this device. On the contrary, the period of the received wave (~ 35 µs) can be ascribed to the second mode of vibration of the

delaminated plate, which is excited by the shear pulse applied on the surface. This interpretation is corroborated by the comparison with the dominant frequency detected via the impact acoustics technique, which is consistent with the expected ratio between the first two natural vibration frequencies of the circular slabs.

Following the assessment of the pavement conditions, an appropriate repair technique has been designed, in order to fulfil a series of practical requirements: short interruption of the operations in limited parts of the facility, most favourable balance between materials and labour costs, substantial improvement of the pavement durability regardless of the local conditions of the supporting ground-slab. The technique is based on the replacement of the pavement layers only along three 0.3 m strips, slightly exceeding the trails of the truck wheels (Figures 8a). The adopted material is a high-performance epoxy-based grout, whose long-term connection to the substratum is guaranteed by a series of 8 mm stirrups arranged at 0.20 m intervals and glued into drilled holes.
