A neutron diffraction and imaging study of ancient iron tie rods

INTERNATIONAL WORKSHOP ON IMAGING II
4–8 SEPTEMBER 2017
VARENNA, ITALY

ABSTRACT: Milan Cathedral is one of the biggest and widest churches ever built among the other coeval architectures. It had a very long and complex construction history, which started in 1386 and lasted more than four centuries. The dominant style is the European gothic but the lombard tradition has strongly influenced the composition. Gothic cathedrals were diffusely built in Europe during the Middle Age, and each region developed its own local interpretation. However, a common feature of the style was the presence of slender pillars and of many elements able to reduce the horizontal thrusts of the vaults, such as spires, buttresses, flying buttresses and tie rods. In Milan Cathedral, tie rods have a fundamental role due to the specific characteristics of the structural system and its complex history. In 2012, a broken tie rod was found and it was substituted with a new one. Therefore, a multidisciplinary research on these elements started, aiming at a deeper material characterization and an *in-situ* identification of local defects. Among non-d

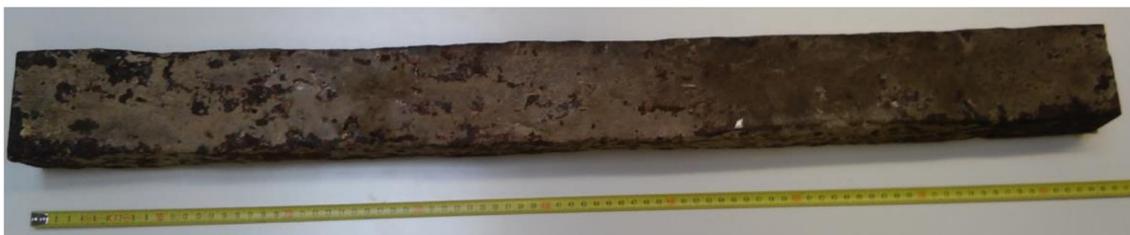
Figure 1. Portion of an ancient tie rod from Milan Cathedral (1400 AD).

The main sample comes from a part of the original broken tie rod of Milan Cathedral. It has a rectangular cross-section. Its surface is very rough and is characterized by a layer, with thickness of 0.2–0.3 mm, which could be calamine (an oxide produced during the hot working) coupled with a coherent dust layer built-up in the ages. A picture of the sample is shown in figure 1. Sample sizes are about 85 × 55 × 840 mm³, and 30 kg mass.

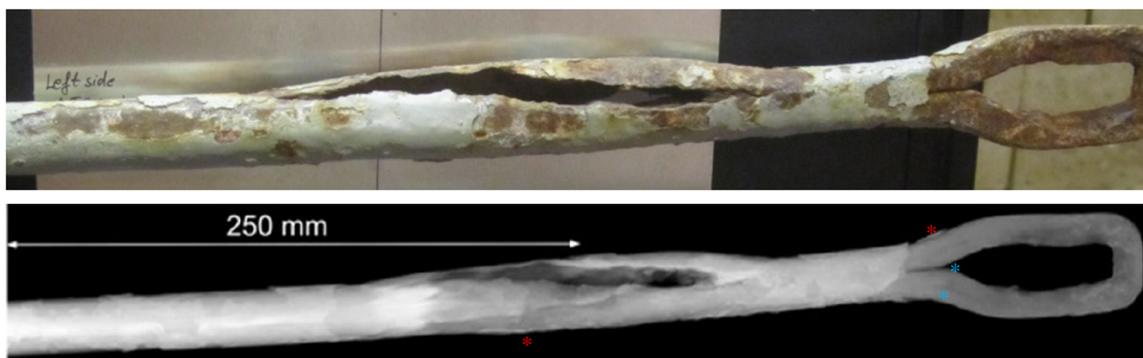
Figure 5. Visible appearance and neutron radiograph of another tie rod coming from an external spire. Crackings due to the atmospheric exposure are evident, but also other interesting inner details. See text for further comments.

Figure 5 reports another radiograph from a different tie rod. In this case the effects of atmospheric exposure are already evident from the picture. Again, points marked by a red asterisk identify some patinas or pigments (containing hydrogen), while blue asterisks denote voids. The biggest void is clearly visible by naked eye. This could be a point where the alteration process begun (being an access for water or humidity to penetrate the rod). Another “empty line” is clearly highlighted by neutron imaging (visible also in figure 4). In both cases, due to their position and behaviour (following the “ring” shape of the tie rod), these “empty lines” could be associated with the manufacturing technique too.
