Assessment of an industrial pavement *via* the impact acoustics method

Roberto Felicetti

EJECE - 14/2010. On site assessment of concrete structures, pages 427 to 439

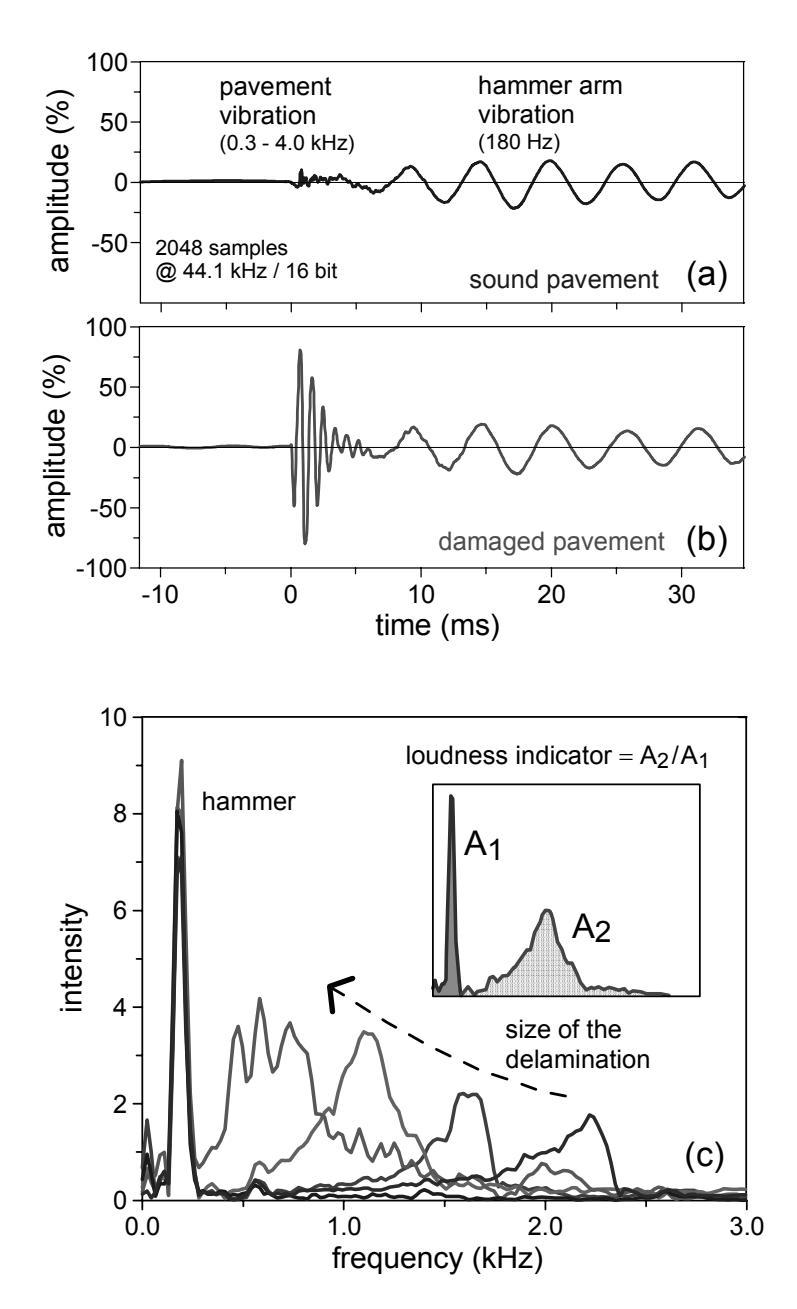
In general, the signal recorded after a single hammer blow exhibits two well distinct components: an initial wave of relatively high frequency (in the order of 1 kHz), which tends to fade away within about 30 ms, and a more stable wave of well defined frequency (180 Hz), starting 5-10 ms after the hammer blow (Figures 4a, 4b). These two parts can be easily recognized on the frequency distribution diagrams (magnitude of the Fast Fourier Transform - Figure 4c). The first component is associated to the pavement response and it is strongly related to its local condition, to the point that it nearly disappears in the case of a sound flooring. The lower frequency part is to be ascribed to the mechanical vibration of the arm activating the hammer and it is a function of the tap intensity, which may be slightly affected by the variations in the hammer rebound and in the trolley speed (coefficient of variation $\cong 8\%$).

Figure 4. *Typical recorded signals following a hammer tap on either: a) a sound or b) a damaged pavement; c) frequency spectra at increasing size of the delamination crack and definition of the loudness indicator*
