Structural Analysis of Historical Constructions

Damage observation and settlement mechanisms in the naves of the Cathedral of Milan

G. Cardani, D. Coronelli & G. Angjeliu
Politecnico di Milano, Milan, Italy

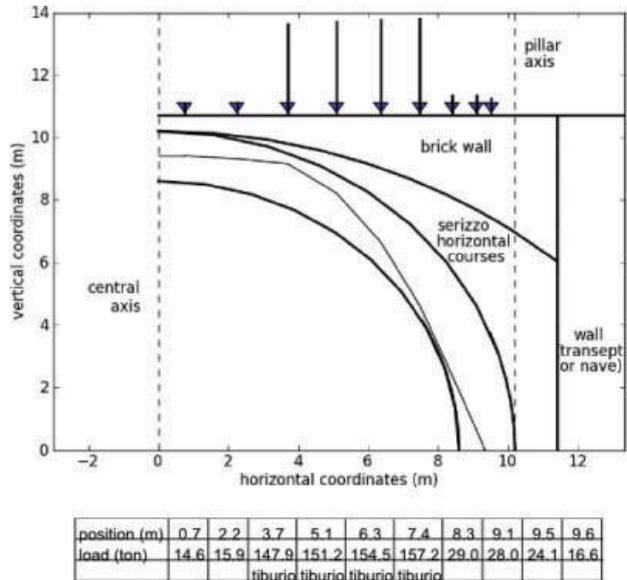
Figure 11. Funicular line in the Tiburio Roman arches, minimum thrust in Phase II (Coronelli et al., 2015).

The funicular line for minimum thrust in case IIa is shown in Fig. 11 (Coronelli et al., 2015).

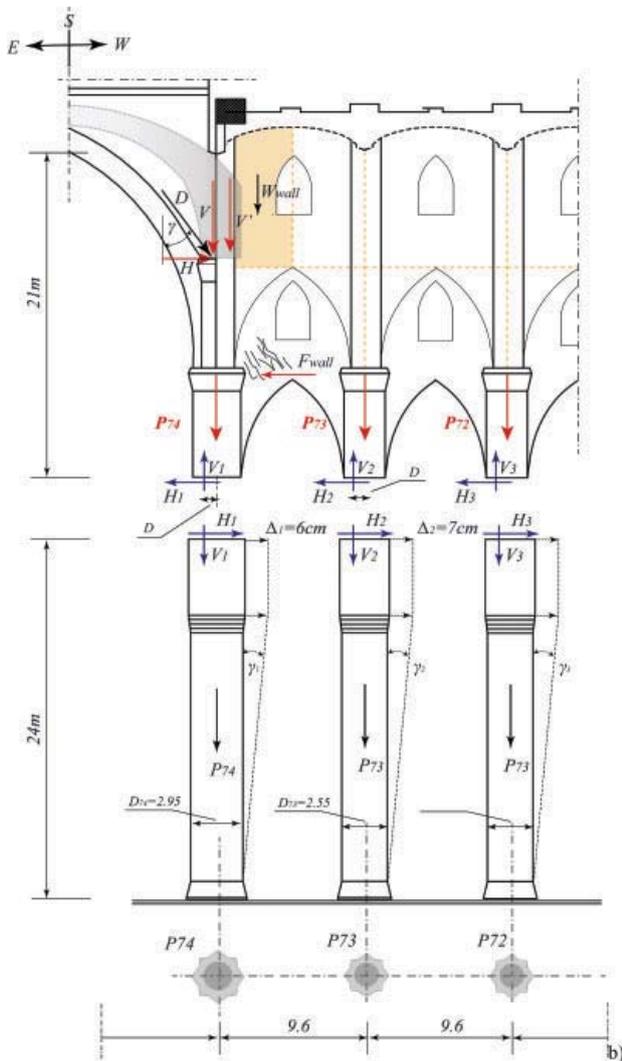
Figure 12. Roman arches reactions (minimum thrust) and equilibrium with forces at the top of the columns.

For the arch thrust transfer into the nave South wall a static solution is proposed in the following. Similar analyses can be formulated for all four corners of the Tiburio connected to the North nave arcade, transepts North and South and choir to the East. The resultant D, with components H and V is shown in Fig. 12b. The thrust is divided into components along different lines, depending also on the geometric constraints imposed by the windows in the wall (Fig. 12b). A first steep line of action (Fig. 12a) reaches the top of the first column (P74). A less inclined line can be drawn, reaching the first arch (P74-P73) at the side of the tiburio and through this the pier support. A third line is directed to the second arch and third column (P72).

Inclined cracking is observed in the wall between P74 and P73 (Fig. 13b) related to diagonal force transfer; the same damage is found in all eight walls at the four corners of the Tiburio. It is assumed that the shear resistance of the wall is reached; considering the vertical load given by its weight, using a Mohr-Coulomb

failure criterion the force transfer in the cracked panel to the right of P74 is a horizontal component of 65 ton, with a vertical component of 86 ton. The remaining force transfer is solved by equilibrium, given the loads in the system (not shown for the sake of brevity).

Fig. 12 shows horizontal equilibrium with thrust H balanced by the column horizontal reactions H_p . In a static analysis scheme the maximum possible values of the column horizontal reactions H_i depend on the vertical force on the columns V_i summed to their weight

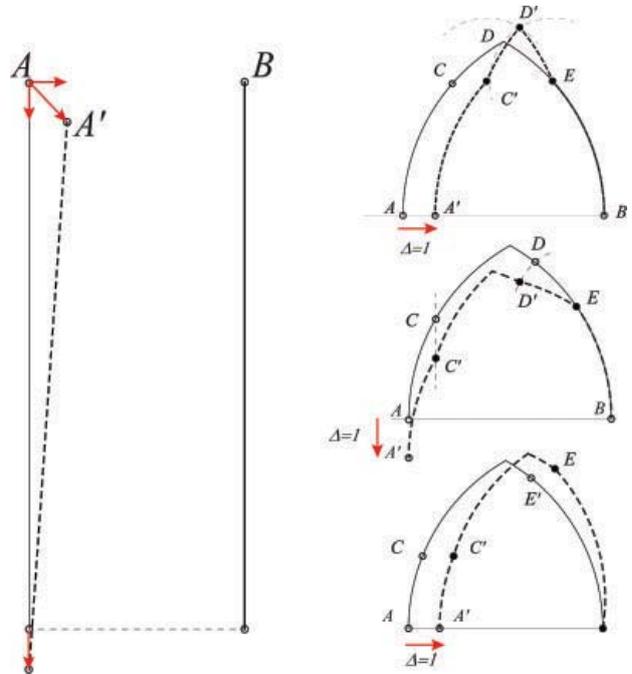
Figure 15. Settlement and rotation of a pillar (left) and settlement mechanisms in the arches (right).

The general trend of the ongoing vertical foundation settlements, provided by the monitoring started in the 1960s, shows an increase in the vertical settlement moving from the side walls to the tiburio piers; this depends on the foundation soil characteristics and the position of the maximum forces on the foundations (Coronelli et al., 2014), reaching over 3600 tons, the double of the nave piers and three times the piers between the aisles. The measurements are available only for the past 50 years (1966–2016), but it is reasonable that the trend due to the soil subsidence, started in the early 20th century, continued in time, though with a lower rate.

In figure 7 column P74 shows the highest settlement, and the differential settlements of the foundations and out-of-plumb in the area at study are high. Relative movements of P73 with respect to P39 were the cause of the tie failure in figure 8. The surveys and repair operations show that most past and present damage is in the vaults between P74 and P7-P8-P9.

With the kinematic method of limit analysis, the settlement mechanisms associated to these measurements are described by the relative vertical displacement at the base and horizontal displacement at the top of the columns (Fig. 14); these are reflected in arch settlement mechanisms with the prevailing possibility of damage with extrados compression; the load calculations are not shown for brevity.
