# Metallurgical characterisation of a historical metal tie-rod from Milan Cathedral

One tie-rod from Milan Cathedral (15th century) recently broke in a defective cross-section. In order to infer the causes of failure, a metallurgical characterisation was performed, the results of which are discussed here. First, a visual inspection of the specimen was performed. Next, the fracture surface was analysed using a Scanning Electron Microscope (SEM) combined with Energy Dispersive X-Ray Spectrometry (EDXS) to detect the failure modes involved. A cross-section close to the failure surface was investigated by means of Stereoscopy, Light Optical Microscopy (LOM), SEM and EDXS in order to identify the microstructural compounds and characterise the slag inclusions. Vickers and Rockwell hardness tests were also carried out to correlate microstructural observations with mechanical properties. A strong relationship between failure and defects due to forging was observed, which is a particularly noteworthy result with regard to the representativeness of laboratory tests and the viability of in-situ inspection.

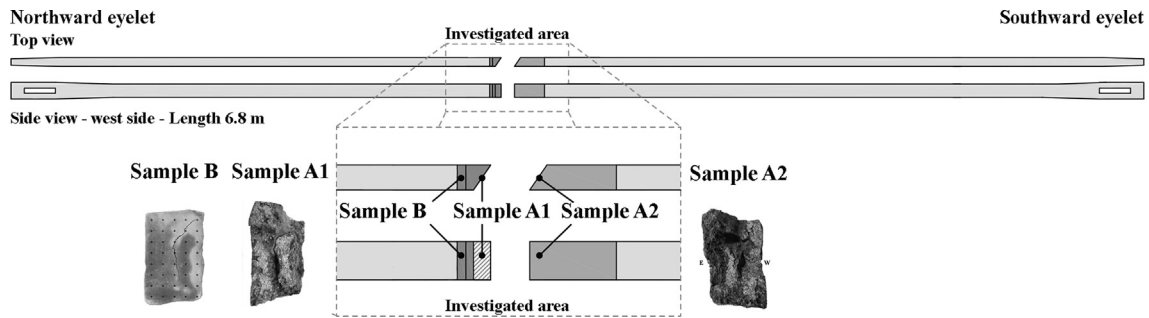
Fig. 1. Location of the investigated samples.

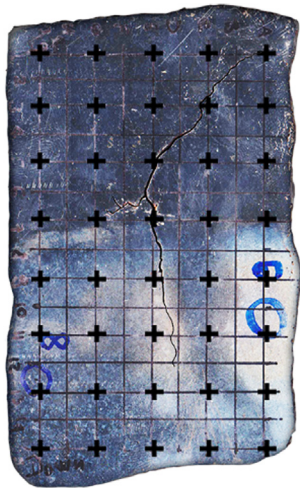
Fig. 8. Reference grid.

coordinate the results provided by different techniques, a grid of 40 points, with a spacing of 10 mm, was traced (Fig. 8).
