The analysis of the main spire reversed arches of the Cathedral of Milan

D. Coronelli, G. Cardani & G. Angeliu

Politecnico di Milano, Milan, Italy

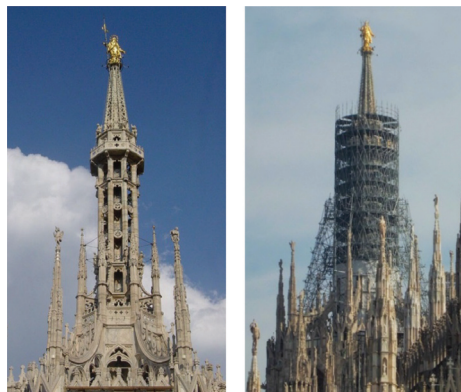
Figure 1. Main spire and scaffolding (VFD 2015).

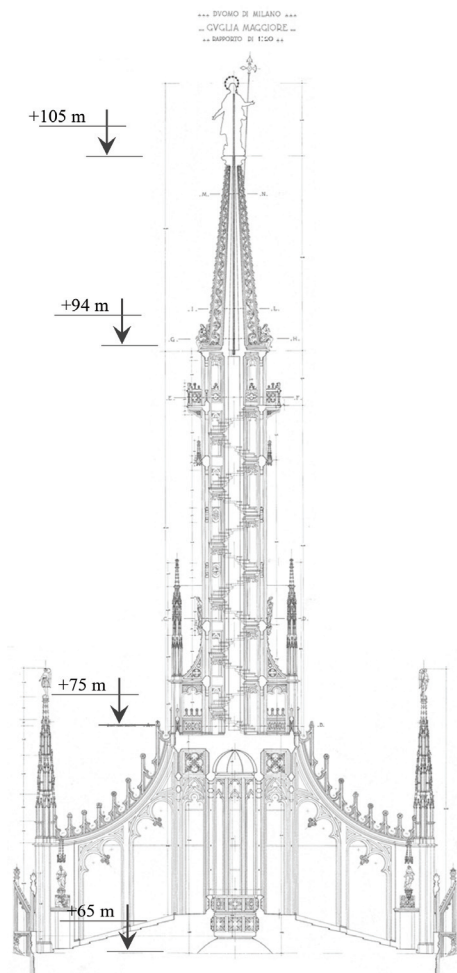
In addition, many connection “staples” (Beckmann and Bowles, 2004) are placed hidden within the masonry blocks: for example iron links to connect the elongated blocks along the arches (Fig.2) and vertical studs to connect the decoration tracery

Figure 2. Section of the main spire of the Duomo along a radial plane (Ferrari da Passano 1988, Corradi & Calvi 2009).

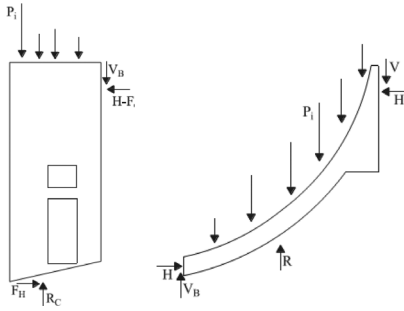
The verifications of the buttresses were then carried out. For combined bending and axial force, the safety factor at the ULS (ultimate limit state) derived from the moment ratios (M_{Rd}/M_{Ed}) is 1.42. The second case is not verified as the ratio results 0.98 (even though it is close to 1 and within a safety margin of 5%). As a result, repair works had to be carried out with strengthening around the respective arches.

Figure 15. Equilibrated loads on buttress and reversed arches.

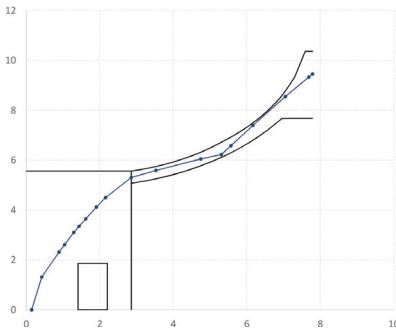
The thrust line analyses are carried out simplifying the geometry of the system as schematically drawn in Figure 15. The calculated forces are applied as V and H ; a reaction force R is at the intermediate column support; the self-weight of the structure is applied as the P_i forces (Fig. 15). Historic drawings were examined and compared to a 3d laser scan results: a constant cross-section of the arch is determined, starting from the exterior buttress up to the connection with the main spire; here the cross section has a greater depth. Considering the strength of the stone masonry limited, an interior part of the cross-section within which the thrust line must lie is determined: greater eccentricity of the internal compression force would crush the masonry. One of the infinite equilibrated solutions is plotted in Figure 16. It is the one in accordance with the experimental damage observation in-situ.

Figure 16. Thrust line within the reversed arch.
